DEPARTMENT OF TRANSPORTATION**DIVISION OF ENGINEERING SERVICES**

Quality Assurance and Source Inspection

Contract #: 04-0120F4Cty: SF/ALA Rte: 80 PM: 13.2/13.9File #: 69.28**WELDING INSPECTION REPORT****Resident Engineer:**Siegenthaler, Peter**Address:** 333 Burma Road**City:** Oakland, CA 94607**Report No:** WIR-019115**Date Inspected:** 02-Jan-2011**Project Name:** SAS Superstructure**OSM Arrival Time:** 700**Prime Contractor:** American Bridge/Fluor Enterprises, a JV**OSM Departure Time:** 1900**Contractor:** Zhenhua Port Machinery Company, Ltd (ZPMC), Changxing Island **Location:** Shanghai, China**CWI Name:** Xu tao**CWI Present:** Yes No**Inspected CWI report:** Yes No N/A**Rod Oven in Use:** Yes No N/A**Electrode to specification:** Yes No N/A**Weld Procedures Followed:** Yes No N/A**Qualified Welders:** Yes No N/A**Verified Joint Fit-up:** Yes No N/A**Approved Drawings:** Yes No N/A**Approved WPS:** Yes No N/A**Delayed / Cancelled:** Yes No N/A**Bridge No:** 34-0006**Component:** OBG Components**Summary of Items Observed:**

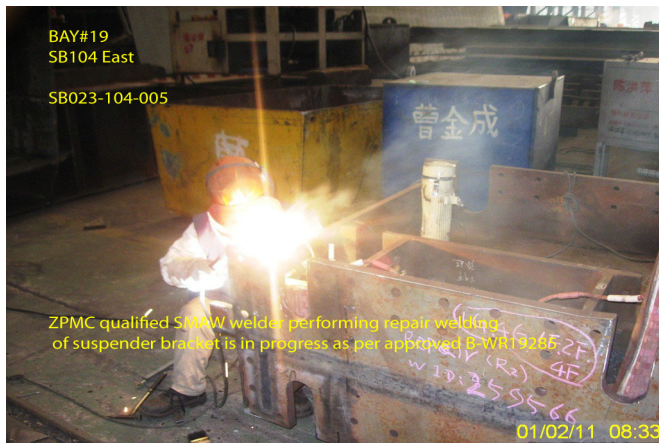
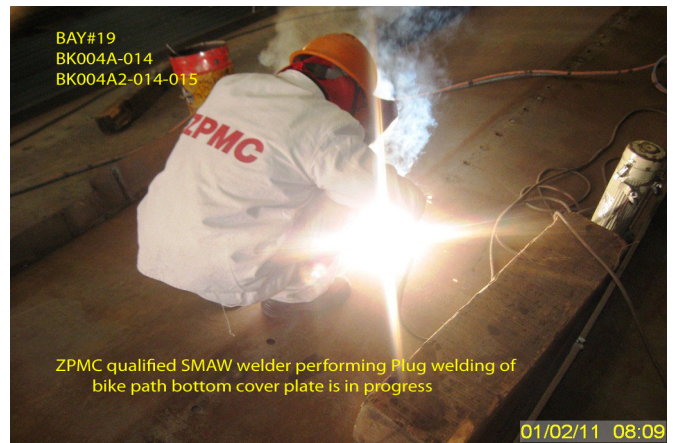
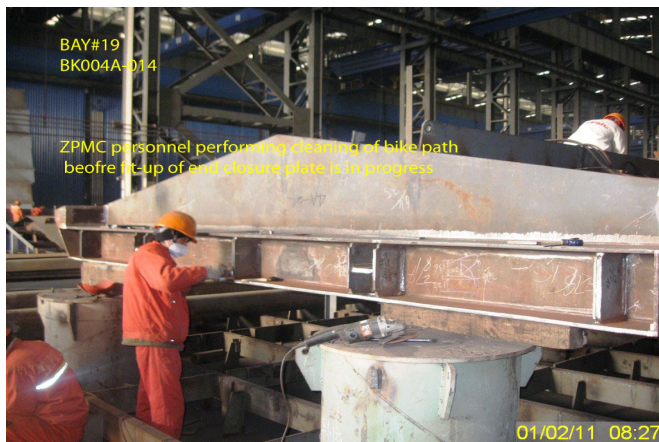
SMAW welding of repair weld (R2) is identified as 1G-005 of SB023-104 for SB104 East. The welder is identified as 259566. ZPMC QC is identified as Mr. Guo xing hui. The welding variables recorded by QC are appeared to comply with the WPS-345-SMAW-1G-Repair and WR19285.

SMAW welding of repair weld (R2) is identified as 1G-005 of SB022-104 for SB104 West. The welder is identified as 259906. ZPMC QC is identified as Mr. Guo xing hui. The welding variables recorded by QC are appeared to comply with the WPS-345-SMAW-1G-Repair and WR19488.

FCAW welding of repair (R2) weld is identified as 3G-006 of SB023-104 for SB104 East. The welder is identified as 062761. ZPMC QC is identified as Mr. Guo xing hui. The welding variables recorded by QC are appeared to comply with the WPS-345-FCAW-3G-ESAB-Repair and WR19286.

FCAW welding of repair (R2) weld is identified as 3G-002 of SB022-104 for SB104 West. The welder is identified as 062761. ZPMC QC is identified as Mr. Guo xing hui. The welding variables recorded by QC are appeared to comply with the WPS-345-FCAW-3G-ESAB-Repair and R19487.

ZPMC QC UT personnel performing Ultrasonic testing of suspender bracket weld is in progress.
The suspender bracket is identified as SB106E, SB108E.

Visual inspection of cleanliness and welds carried out before fit-up of end closure plate of bike path is identified as BK004A-014.
